Manhole Inspection Summary

Manhole # S350__005MH

Insp Date: **7/27/09 4:53 PM**

Location Address: **122 WARREN ST.**

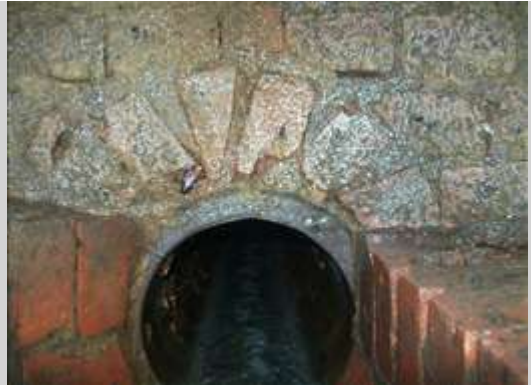
12 O'Clock Outflow

8 in. Circular Gravity Sewer
Pipe Out @ 12 O'Clock

Pipe Height: **7.2** (in.) Rod and Bar (Angled)
Pipe Material: **Clay** ☐ Pipe Lined
Invert Depth: **13.11** (ft.) Flow Characteristics: **Slow**
Deposits: ☒ None ☐ Mud ☐ Sludge ☐ Debris ☐ Grease
Silt Depth: **0** (in.) Deposits Extent:
Infiltration: **None** Pipe Seal Cond: **Sound**

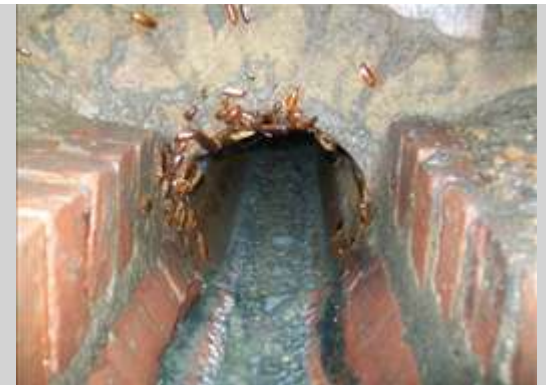
6 O'Clock Inflow

8 in. Circular Gravity Sewer
Pipe In @ 6 O'Clock

Pipe Height: **7.2** (in.) Rod and Bar (Angled)
Pipe Material: **Clay** ☐ Pipe Lined
Invert Depth: **12.92** (ft.) Flow Characteristics: **Fast**
Deposits: ☒ None ☐ Mud ☐ Sludge ☐ Debris ☐ Grease
Silt Depth: **0** (in.) Deposits Extent:
Infiltration: **None** Pipe Seal Cond: **Sound**
